For customers using the Cutting Blade Holder PHP33-CB09-HS

We have found that the cap portion of the blade holder “PHP33-CB09-HS” may be damaged.

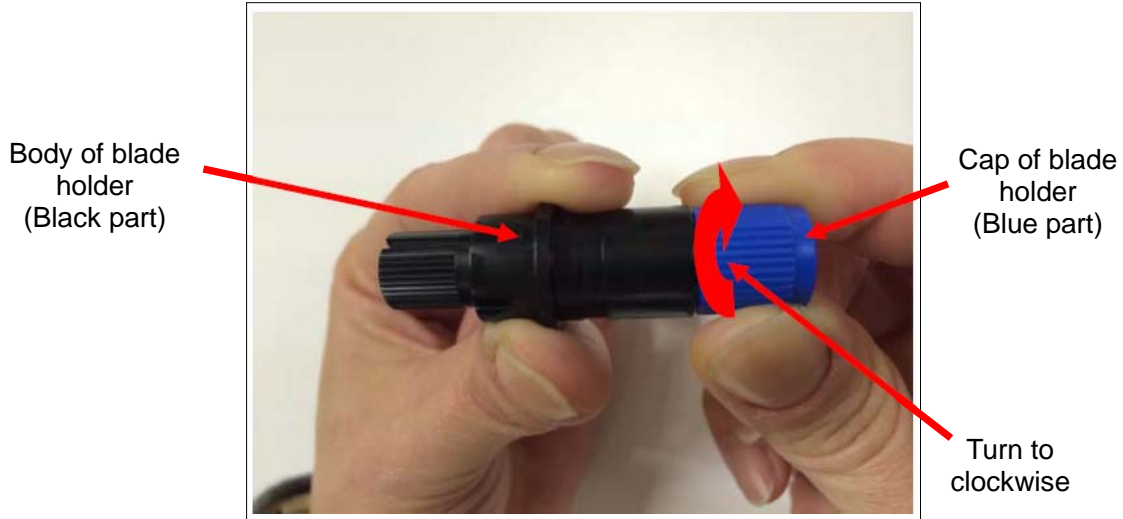
Please check the PHP33-CB09-HS blade holder when you use it the first time. Before mounting the cutter blade, the cap of the blade holder is installed to the body of the blade holder. The cap is turned in a clockwise until it stops for it. When you apply a force to turn further clockwise from the position stopped, it will be damaged if it has the problem.

If it occurs, please contact to your local representative of Graphtec who provide the CE6000, FC8600, or the PHP33-CB09-HS to you. We will provide the replacement in free of charge through your local representative of Graphtec.

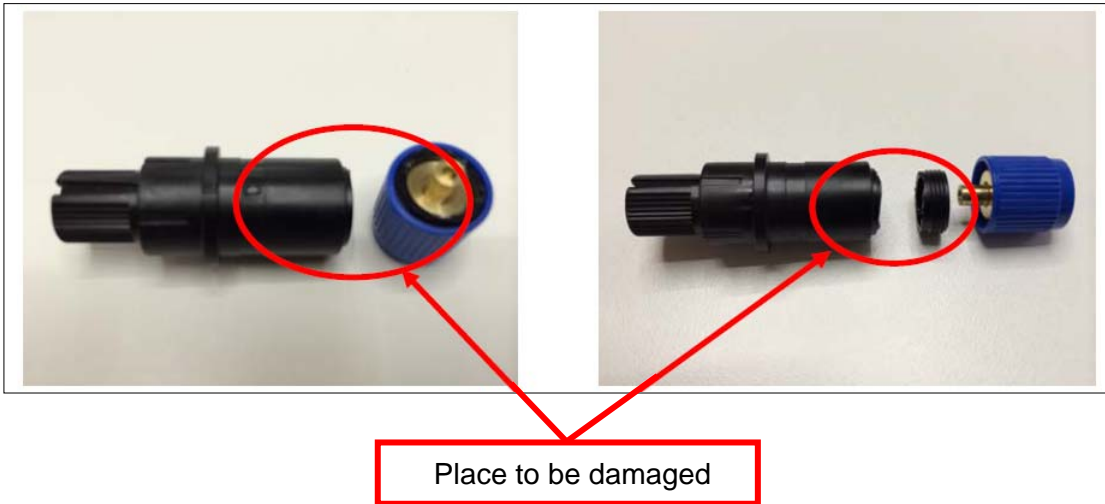
The damage occurs when you install a cutting blade to the blade holder at the first time, or immediately after unsealing it.

Damaged cutter blade holder

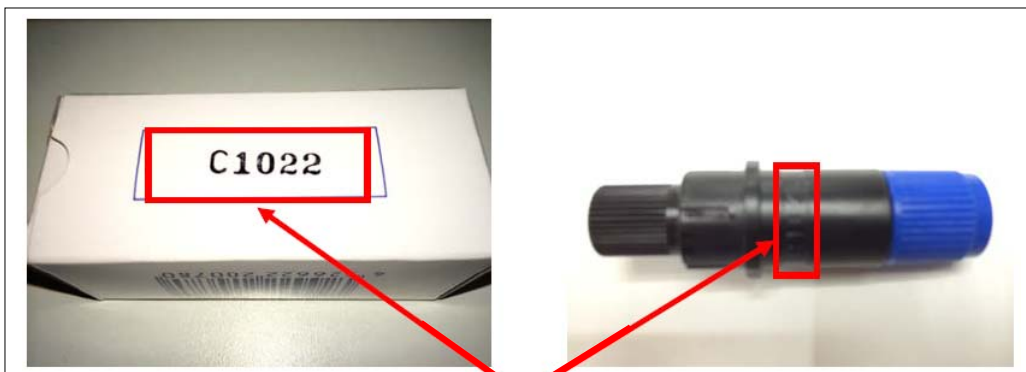
Manufacturing Lot-number

The lot-number is shown in the package and the blade holder. Those are shown above. Number is the following.
"One (1) digit of alphabet & four (4) digits of numbers"

We would ask that please you report the manufacturing lot-number of the cutting blade holder when you find the damage.
